AIRWORTHINESS DIRECTIVE

ENGINE FUEL AND CONTROL – F	LOAT - INSPECTION/REPLACEMENT
-----------------------------	-------------------------------

AD No: 2016-0002

BRP-POWERTRAIN GmbH & Co. KG Rotax 912 and 914 engines

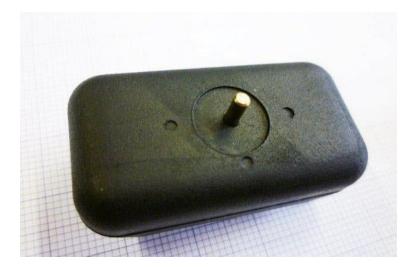
Note 2: For the purpose of this AD, an affected float is float having P/N 861185, that has been initially delivered on a date between 09 May 2016 and 17 July 2016 (inclusive), and that does not have 3 dots. Certification documents (e.g., Form 1), delivery document or record of previous installation of the float are acceptable to determine an initial delivery on or before 08 May 2016. An example of a serviceable float having 3 dots is shown hereunder:

- (2) For any affected engine, before next flight after the inspection as required by paragraph (1) of this AD, replace any affected float with a serviceable float (see Note 2) in accordance with the instructions of the ASB.
