MARINE SAFETY INVESTIGATION REPORT

**Safety investigation into the fatality of a crew member and the collapse of
two other, due to heat exhaustion on board the
Maltese-registered bulk carrier
ELPIDA GR
in the port of Mesaieed, Qatar,
on 27 July 2023**

MARINE SAFETY INVESTIGATION REPORT NO. 10/2024

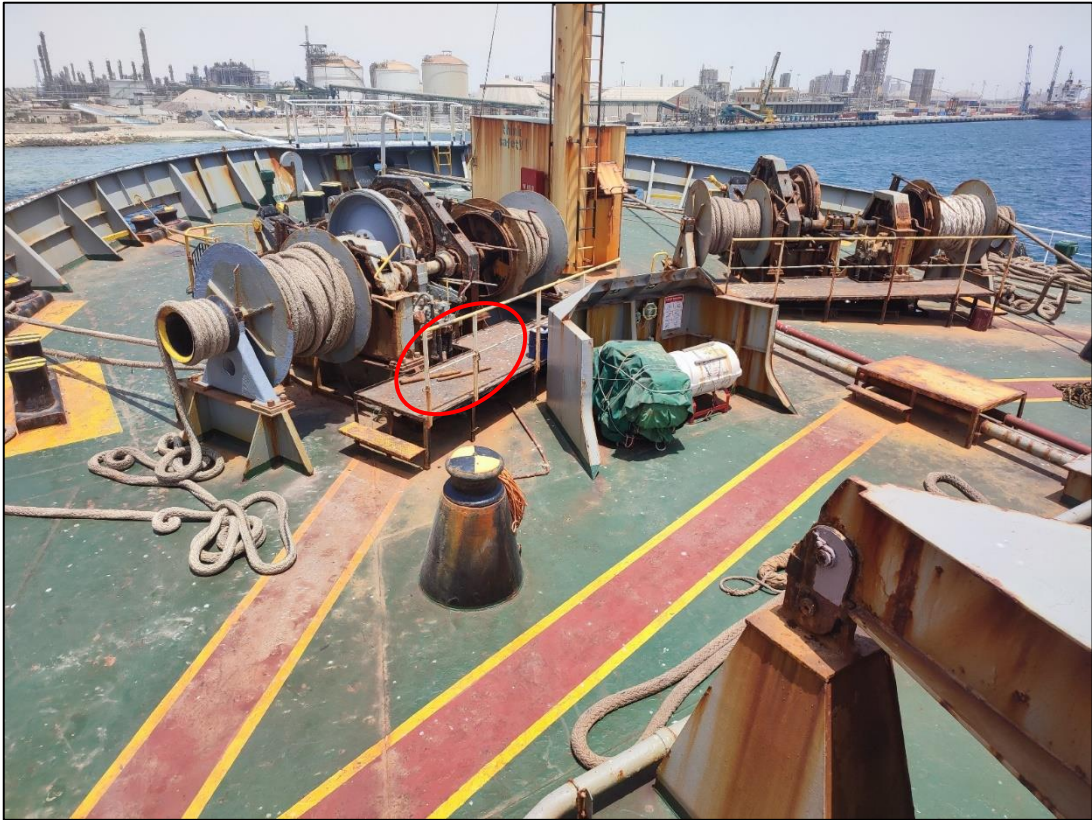
The cook, messman, and O/S 1 carried the bosun to the accommodation external area on the main deck, after which, they removed the bosun's clothes and started fanning him to help cool his body. The cook and the messman then tended to the bosun, while O/S 1 proceeded back to the forecastle deck. At around 0915, A/B 1 collapsed on the forecastle deck (**Figure 2**).

Figure 1: The bosun's location (red circle) when he collapsed

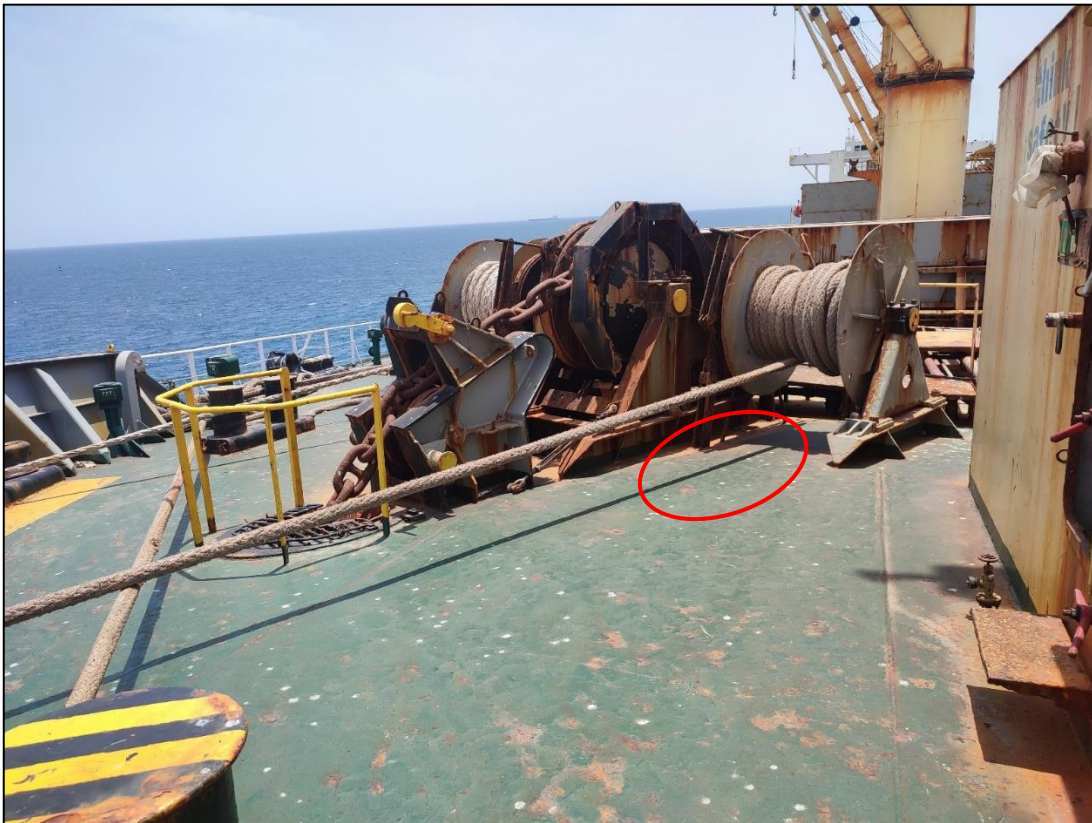
Figure 2: A/B 1's location (red circle) when he collapsed

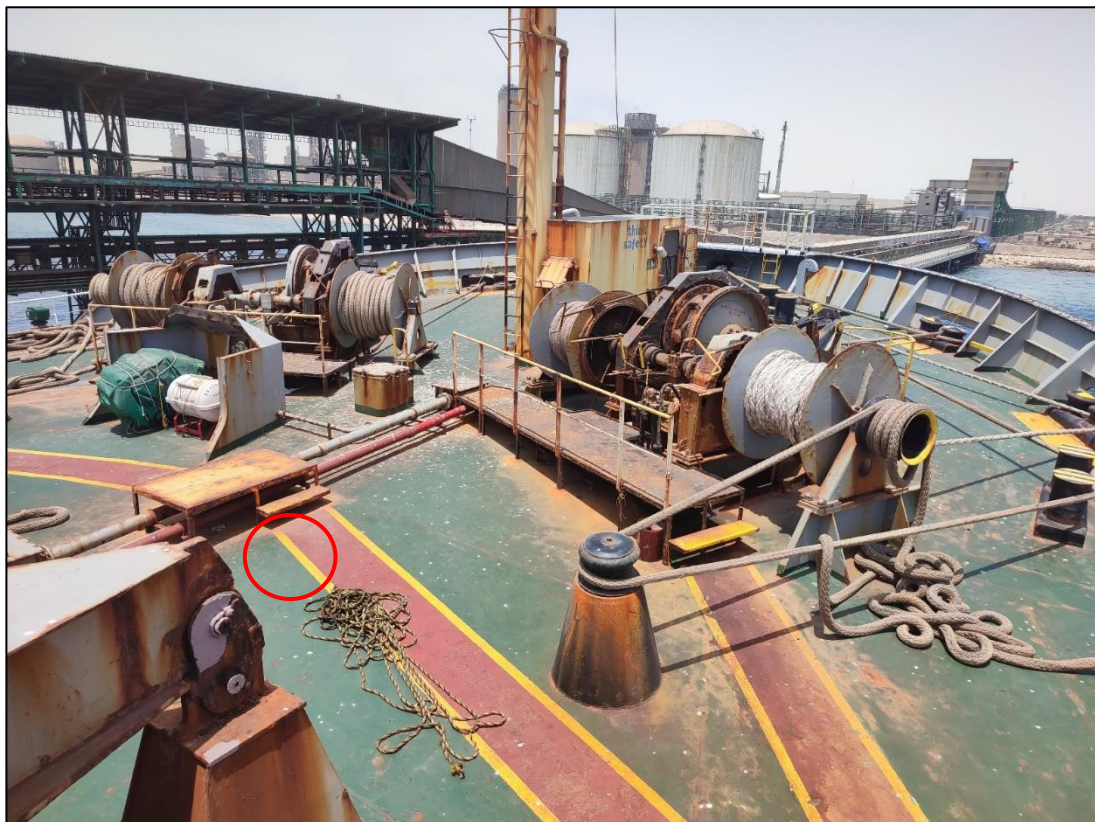
Shortly after, the master rushed to the forecastle deck to assist in making fast the mooring ropes. At 0940, whilst the master was on the forecastle deck, O/S 1 too collapsed (**Figure 3**).

Figure 3: O/S 1's location (red circle) when he collapsed
