SAFETY INVESTIGATION REPORT

REPORT NO.: 15/2024

MT AMUR STAR **Tipping of loose steel plates** **on a crew member,** **in position 54° 12' N 007° 14' E** **21 November 2023**

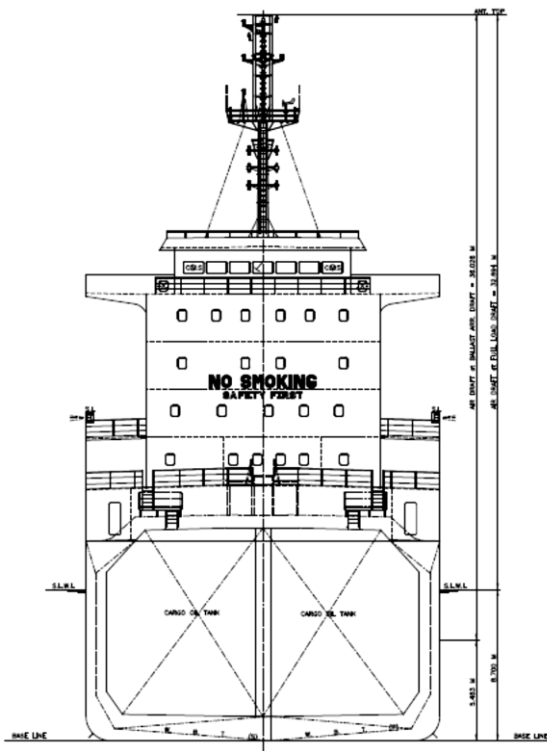
Figure 1: GA Plan MT Amur Star

Amur Star (Figure 1) was a Maltese-registered oil / chemical tanker of 8,581 gt. It was built in 2010 at the 21st Century Shipbuilding Co. Ltd., South Korea. The vessel's registered owners were Valloebly Amur Star Ltd. and was managed by CST Schiffarts GmbH & Co. KG based in Hamburg, Germany. *Amur Star* was classed by Lloyd's Register, which also acted as the recognised organisation for the compliance of the International Safety Management (ISM) Code.

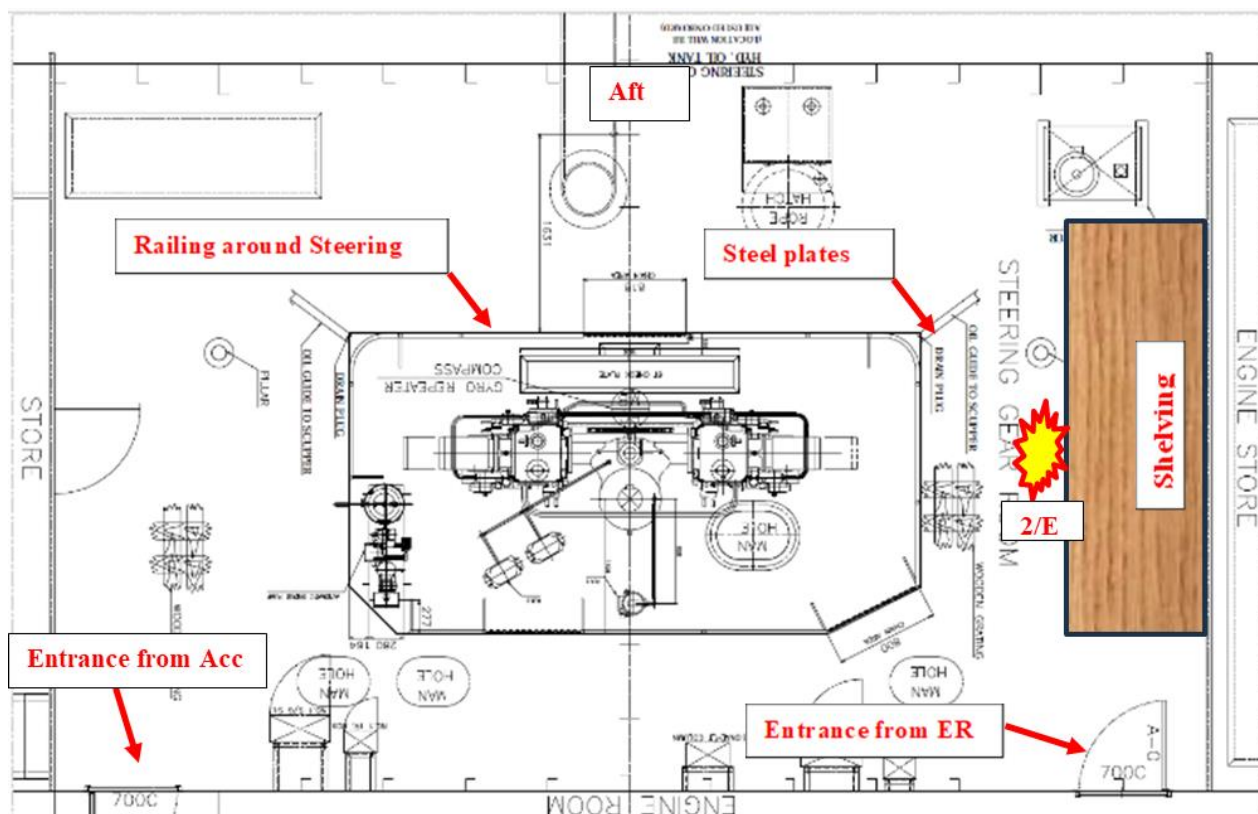
Figure 2: Plan of the steering gear compartment

He kept looking for him, proceeding to the steering gear compartment. There, he found the second engineer unconscious and trapped between the spare parts shelving and several steel plates that appeared to have tilted on him (**Figure 2**). He immediately went to the ECR, called the bridge for assistance, and then went to the CCR to inform the chief officer of the matter. The time noted was about 0935.

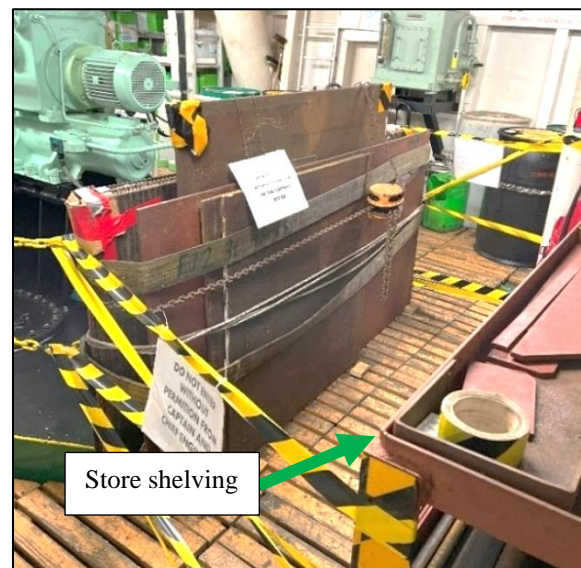
Figure 3: Stack of steel plates

The stack consisted of 15 steel plates of various dimensions (**Figure 3**). There were no records to determine when and why these steel plates had been supplied on board. The largest plate measured 2.04 m * 1.00 m and the smallest measured 1.00 m * 1.00 m. The longer steel plate, seen in **Figure 3**, measured

1.30 m * 1.30 m. The thicknesses of the steel plates varied from 3 mm to 20 mm. Considering that the density of steel is about 7,850 kgm⁻³, it can be appreciated that total weight of the stack was significant.

Information obtained by the safety investigation indicated that the total estimated weight of the stack was approximately 1.2 tonnes. The first plate seen in front of the stack (**Figure 3**) weighed about 188 kg. The chief engineer recalled that the plates had been stowed in that area for more than 12 months and had never been used.

- a poster for the handling, stowage and securing of steel plates and pipes has been prepared and circulated among the fleet vessels;
- non-essential steel plates have been landed ashore;

- extra-reinforcement was welded around the steel plates to restrict them from

- initiated the process for the purchasing of a steel plate stowage rack for all fleet vessels;
- launched a campaign on all fleet vessels for the verification of steel plates securing arrangements on board.

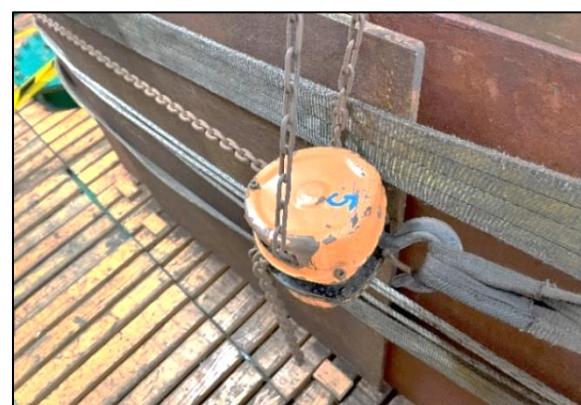
Figure 4: Securing by chain block and nylon slings

The lashing arrangement (**Figures 3 and 4**) consisted of two nylon slings and a chain block.

The lower sling was attached with shackles on either end and was hand tight, while the upper sling was attached with a shackle on the railing at one end, then taken across the plates, looped over a railing, and taken back, where it was fastened to a chain block crown hook. The tail of the chain block was hooked on to the railing at the other end. The plates effectively rested on a hybrid lashing system of nylon slings and a chain block.

The crew members stated that when they removed the stack of plates to free the second engineer, they noticed that both slings were unhooked, the chain block was released, and the lashings were lying on the deck. There was no observed damage to the securing arrangements to suggest that the lashings had somehow failed.

The safety investigation identified several weaknesses and limitations in the applied arrangement. The nylon strops could not be tensioned independently, and a chain block was used to maintain tension on the upper nylon strop lashing. The second lashing appeared to be just hand tightened. It was further observed that the nylon strops were also prone to chaffing against the sharp steel plates edges, potentially resulting in them parting at some stage.

In order to select and take out a steel plate from the stack, the complete lashing arrangement had to be released. This meant that even when alongside with no vessel movement, there was a risk of a significant number of steel plates falling on crew member/s trying to extract one of the steel plates. The weight of the steel plates meant that the attendance of several crew members would have been required to restrain and prevent the plates from tipping over, with the risk of multiple serious injuries to themselves.

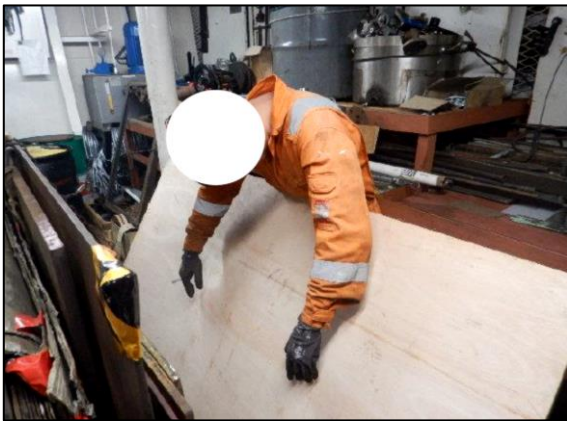
Figure 5: Reconstruction of the accident site
(The figure shows a simulation of the accident)

Crew members who were on scene to assist, confirmed that the second engineer had sustained heavy bruising across his abdomen, in line with where they found the top edge of the steel plates resting against his diaphragm (**Figure 5**).

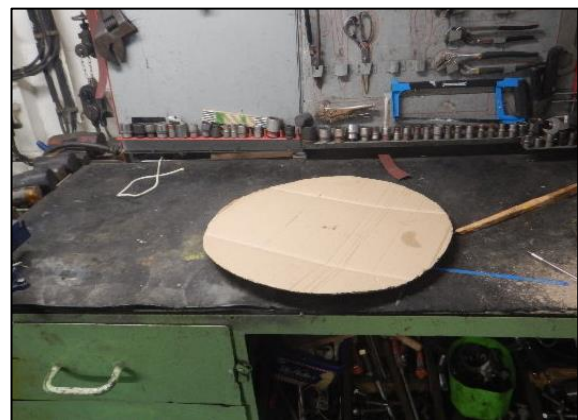
Figure 6: Cardboard template found in the engine-room workshop

The MSIU was informed that no crew member had witnessed the accident. Following the accident, a cardboard template (**Figure 6**) was found in the engine-room workshop, near the empty oil drum that the second engineer and electrician had previously cut off its top.

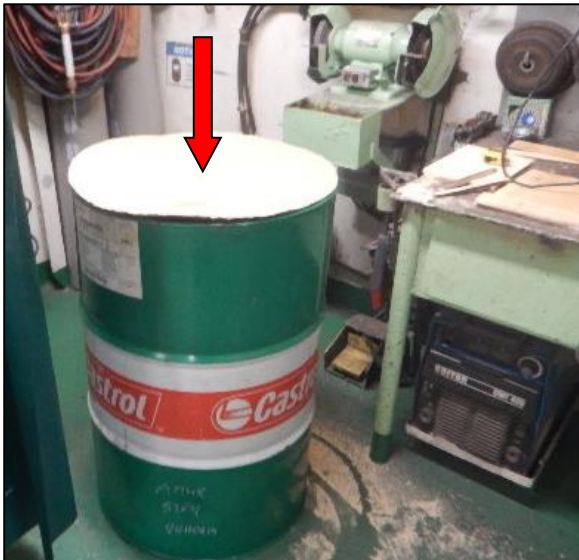
Figure 7: Cardboard template as a lid

The template fitted the oil drum top perfectly (**Figure 7**) and it was deduced that the second engineer may have planned to fabricate a lid for the drum, which was going to be used to store garbage. This logic was reinforced by the fact that the second engineer was tasked with the management of the garbage on board the vessel.
